Advanced Group Property Inspection Co.

<b>Date:</b> 7/16/2009	<b>Time:</b>	<b>Report ID:</b> MK0907025
<b>Property:</b>	<b>Customer:</b>	<b>Real Estate Professional:</b>

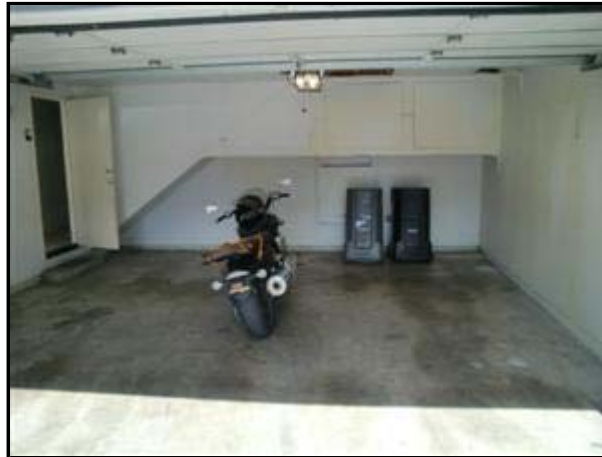
1.0 Picture 1

- Garage (Picture 1)

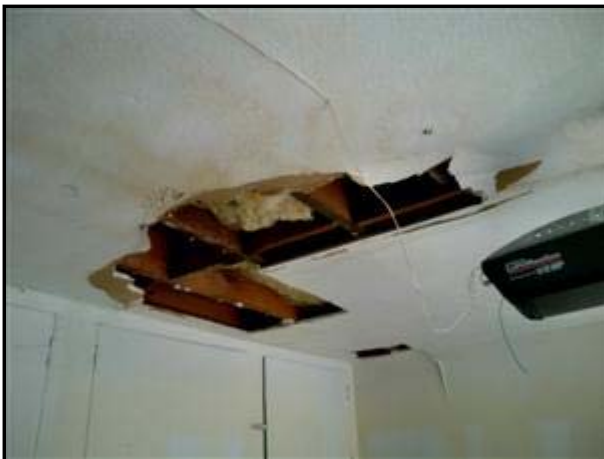
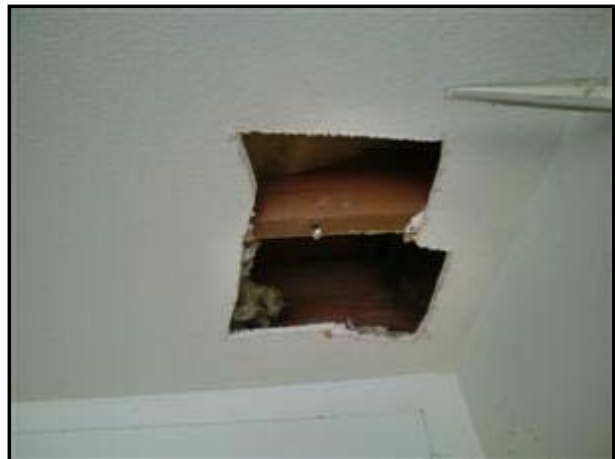
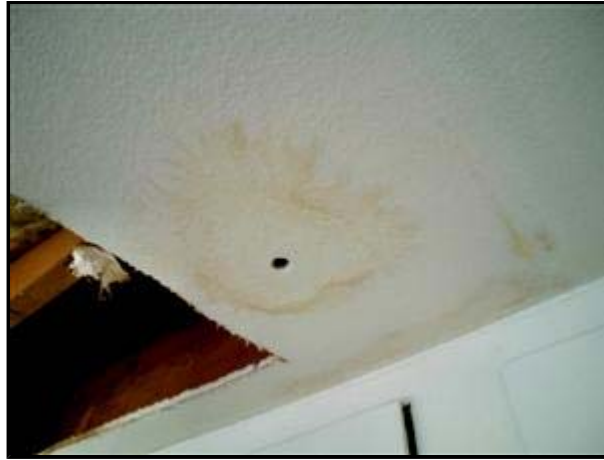
- Holes / Missing materials / damage was noted on the ceiling. This can compromise the firewall. Repairs / Corrections recommended for safety. (Pictures 1-2)
- Moisture stains / damage noted to the garage ceiling. (Picture 3)

- Holes / Missing materials / damage was noted on the ceiling. This can compromise the firewall. Repairs / Corrections recommended for safety. (Pictures 1-2)
- Moisture stains / damage noted to the garage ceiling. (Picture 3)

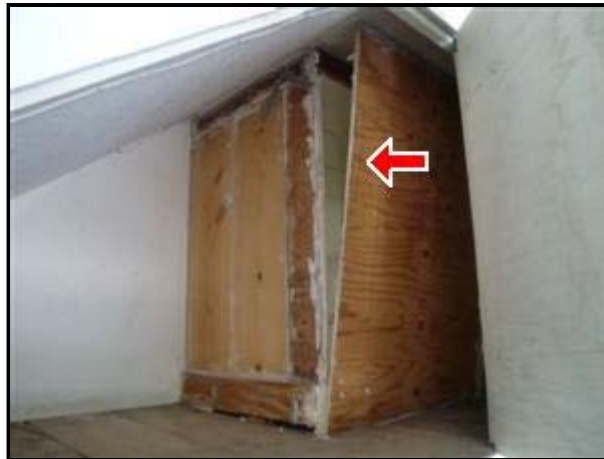
1.2 Picture 1

- Holes / Missing materials were noted on the firewall. Repairs / Corrections recommended. (Picture 1)

- Holes / Missing materials were noted on the firewall. Repairs / Corrections recommended. (Picture 1)

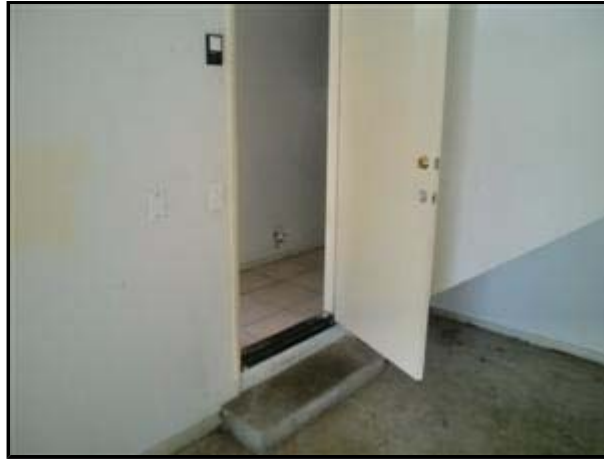
1.4 Picture 1

- Door to interior lacks self closing device / weatherstripping / threshold. Recommend upgrades for safety. (Picture 1)

- Door to interior lacks self closing device / weatherstripping / threshold. Recommend upgrades for safety. (Picture 1)

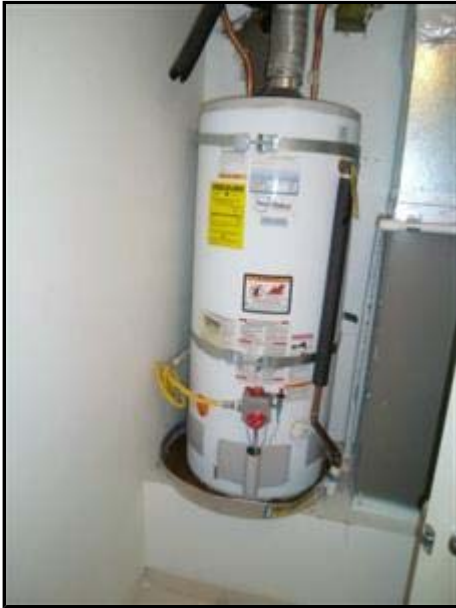
2.2 Picture 1

- Gas line at water heater without drip leg ( this type installation is common for the area). Lack of drip leg may void warranties - check with your Home Warranty provider
- The adequacy or efficiency of the hot water heater cannot be determined in a limited time visual inspection. It is not known how hot the water will get or how long it will last ( this is many times a matter of personal preference).
- Recommend water heater installation meet all current safety standards.
- 40 gallon 2007 unit noted in Utility Room. (Picture 1)

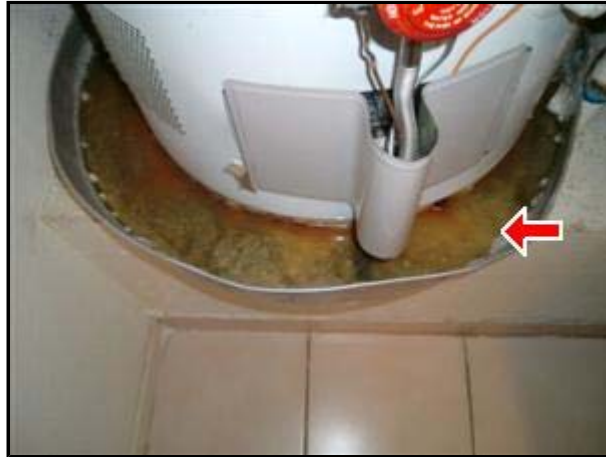
2.2 Picture 2

- Water noted in drip pan - this can indicate a leak in the unit. Recommend further evaluations and corrections as needed by qualified Contractor. (Picture 2)
- Loose seismic straps noted.
- Gas was off - unable to test. Recommend further evaluations once gas is on, pilot lit and tank is heated.

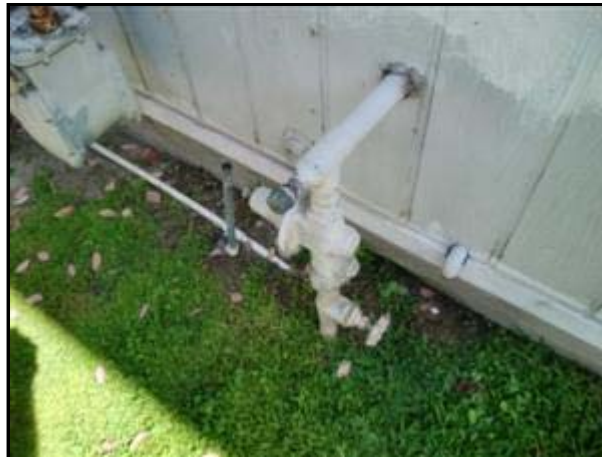
2.3 Picture 1

- Recommend to check the records/permits on copper main re-piping. (Picture 1)

- Recommend to check the records/permits on copper main re-piping. (Picture 1)

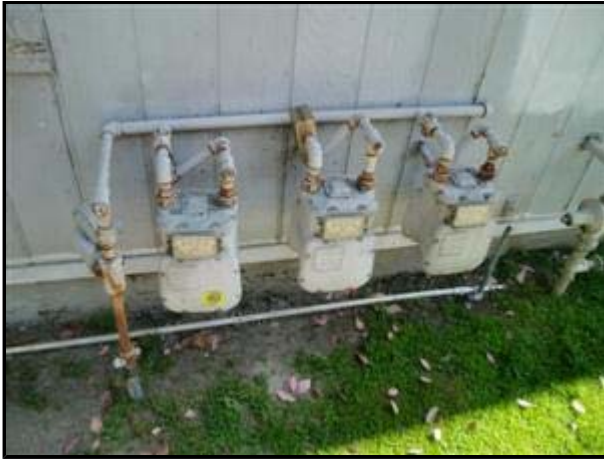
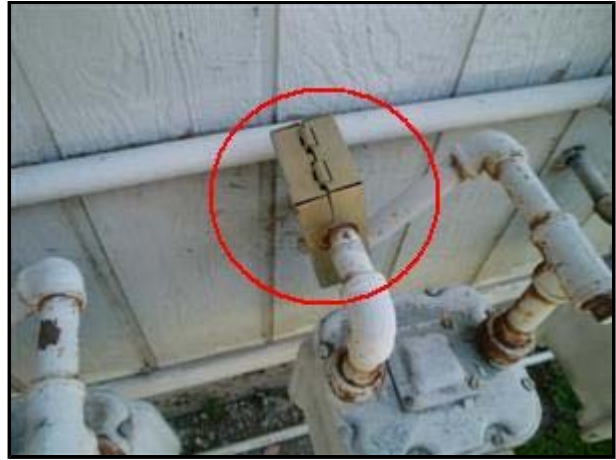
- Gas meter - seismic shut off was not present at the time of inspection - may not be required in the City of Location - recommend to check the local regulations. Seismic shut of valves are recommended on all homes by this Inspection Company. (Picture 1)
- Gas was off - Gas Company "boot" present at the time of inspection - unable to test gas fueled appliances, hot / cold water polarities at sinks, showers etc (Picture 2)

City of Location - recommend to check the local regulations. Seismic shut of valves are recommended on all homes by this Inspection Company. (Picture 1)

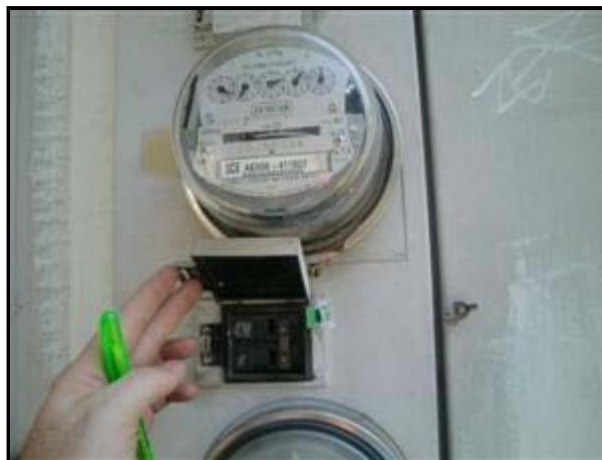
3.1 Picture 1

- 60 amp main panel located at building left side exterior. (Picture 1)

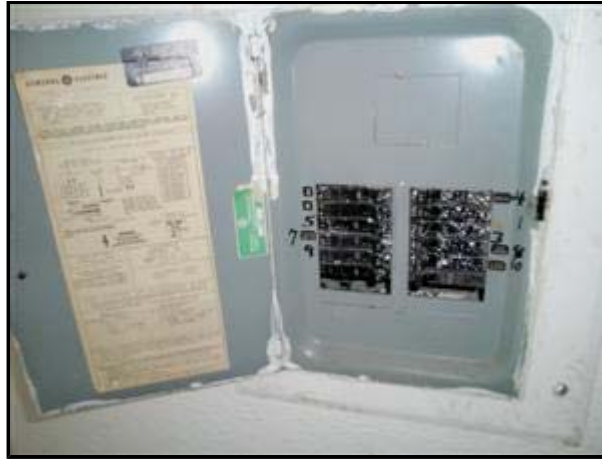
3.2 Picture 1

- Sub panel located in Hallway (Picture 1)
- No labels present - recommend corrections for safety.

- Sub panel located in Hallway (Picture 1)
- No labels present - recommend corrections for safety.

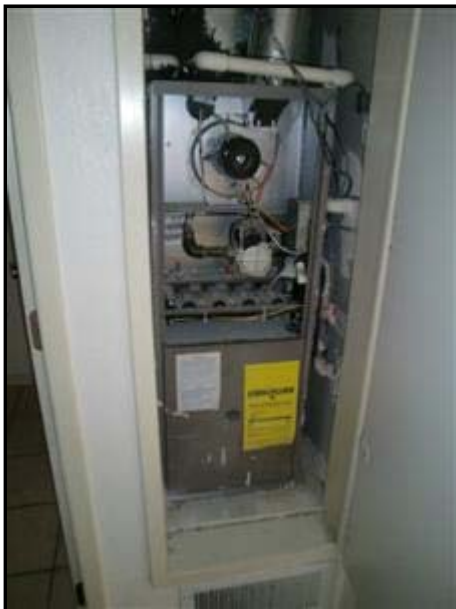
4.0 Picture 1

- Recommend to check the service history with the Seller and to have the unit serviced by a qualified HVAC Contractor if not performed in the past year. (Picture 1)

- Recommend to check the service history with the Seller and to have the unit serviced by a qualified HVAC Contractor if not performed in the past year. (Picture 1)
- No service tags noted. This is a limited Visual Inspection - recommend to have the unit evaluated for safety by a qualified HVAC Contractor.
- Air flow / Balance is not a part of this inspection - recommend to check with the seller regarding air flow / comfort and / or to have the unit checked by a qualified Technician.
- No closet wall or weatherstripping at door present at time of inspection - combustion and return air can mix (this is improper). Recommend further evaluations and upgrades / corrections as needed by qualified HVAC Contractor for safety. (Pictures 2-3)

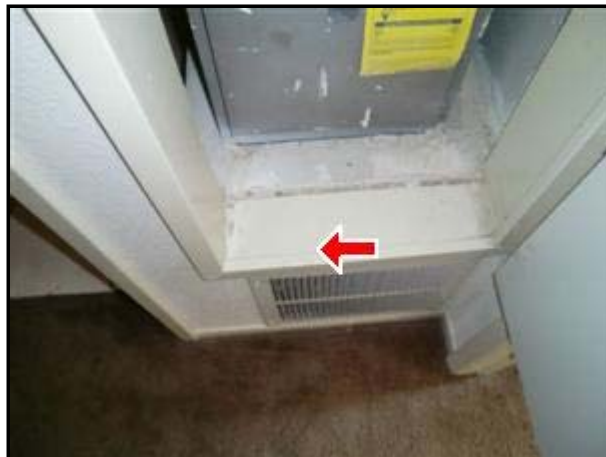
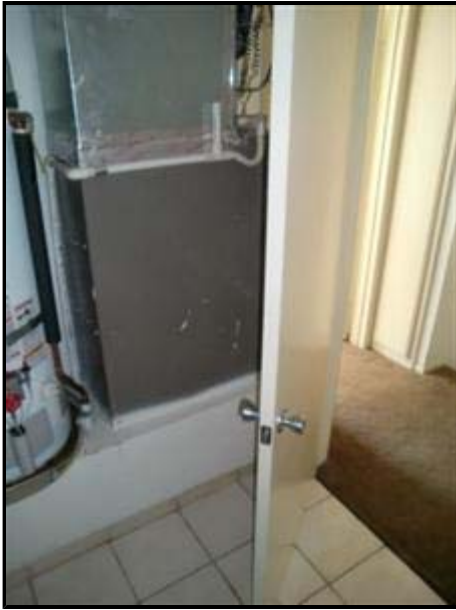
- No closet wall or weatherstripping at door present at time of inspection - combustion and return air can mix (this is improper). Recommend further evaluations and upgrades / corrections as needed by qualified HVAC Contractor for safety. (Pictures 2-3)

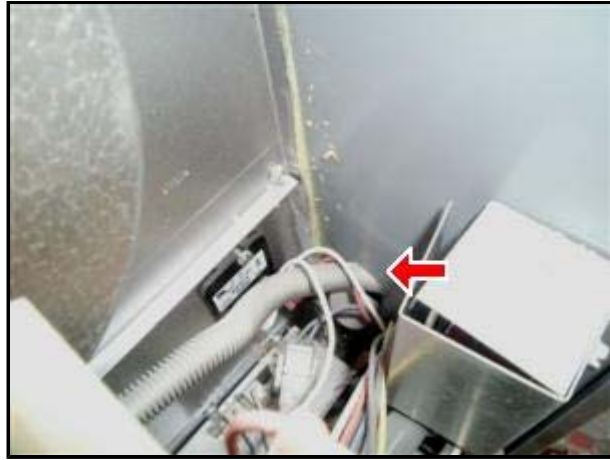
4.0 Picture 4

- Flex type gas line runs in the body of the FAU / Furnace - recommend to change it to rigid type pipe extension. (Picture 4)
- **Gas was off at time of inspection - unable to test. Recommend further evaluations once gas is turned on.**

- Flex type gas line runs in the body of the FAU / Furnace - recommend to change it to rigid type pipe extension. (Picture 4)
- **Gas was off at time of inspection - unable to test. Recommend further evaluations once gas is turned on.**

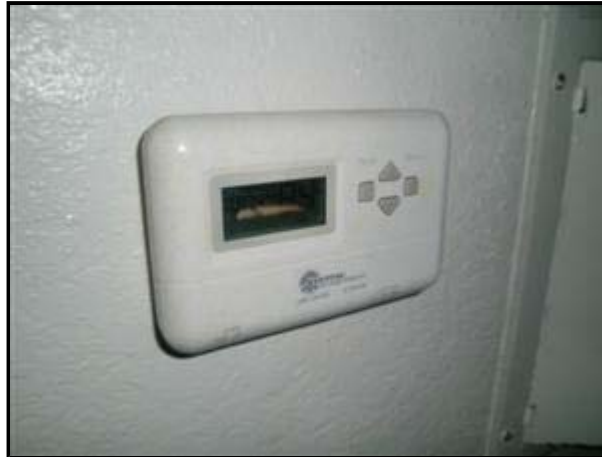
4.1 Picture 1

- Thermostat (Picture 1)

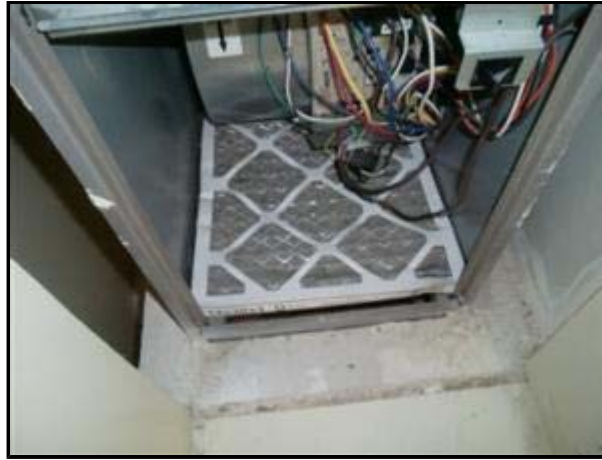
4.3 Picture 1

- Air filters should be changed or cleaned regularly according to Manufacturer's instructions.
- Air filter is not properly installed / lacks filter hold down - unit is not properly filtering return air.(Picture 1)

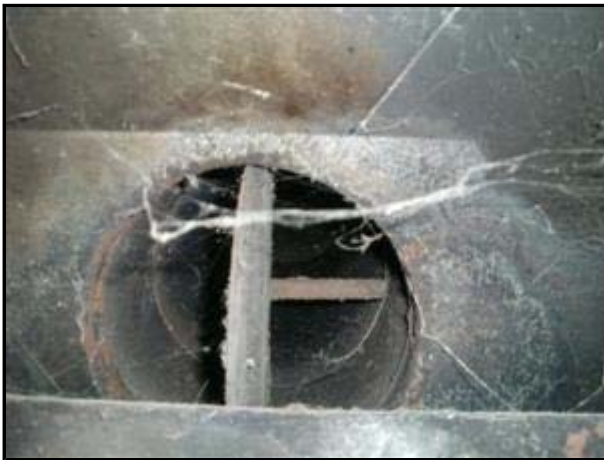
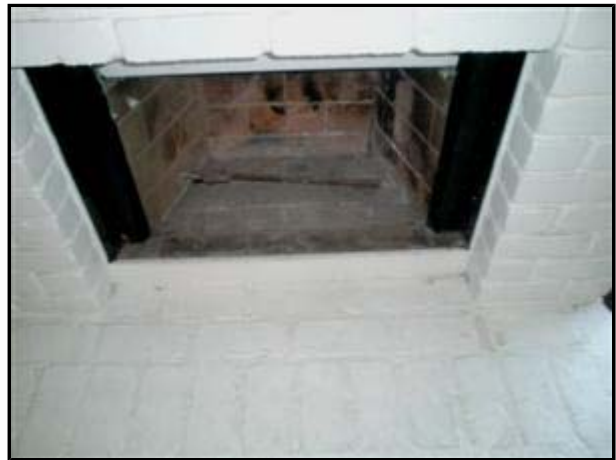
- Video inspection of the flue by qualified Chimney Inspector is recommended. (Picture 1)
- Spark screen is not present - recommend upgrades for fire safety. (Picture 2)

- Video inspection of the flue by qualified Chimney Inspector is recommended. (Picture 1)
- Spark screen is not present - recommend upgrades for fire safety. (Picture 2)

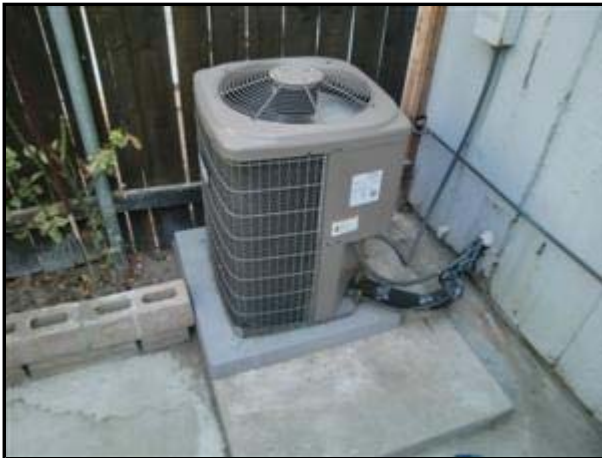
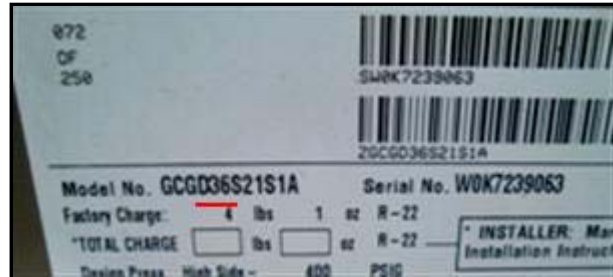
- Unit operated properly at time of inspection.
- Recommend to check the service history with the Seller and to have the unit serviced by qualified HVAC Contractor if not performed in the past year. (Picture 1)
- Air flow / Balance is not a part of this inspection - recommend to check with the seller regarding air flow / comfort and / or to have the unit checked by a qualified Technician
- 3 ton system noted. Unable to determine the exact age of unit at time of inspection. (Picture 2)

- Unit operated properly at time of inspection.
- Recommend to check the service history with the Seller and to have the unit serviced by qualified HVAC Contractor if not performed in the past year. (Picture 1)
- Air flow / Balance is not a part of this inspection - recommend to check with the seller regarding air flow / comfort and / or to have the unit checked by a qualified Technician
- 3 ton system noted. Unable to determine the exact age of unit at time of inspection. (Picture 2)

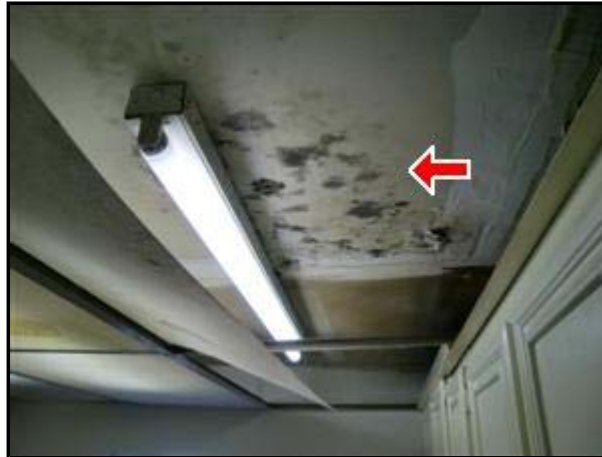
6.0 Picture 1

- Common cracks were noted at the ceilings.
- An active leak was noted at the Kitchen ceiling. I was unable to determine if the leak was from the water heater or one of the bathrooms. Recommend further evaluations and repairs as needed by qualified Plumbing Contractor.
- Signs of mold are present on ceiling in Kitchen . We did not inspect, test or determine if this mold is or is not a health hazard. Recommend you contact a mold inspector or expert for investigation or correction if needed. (Picture 1)

- Common cracks were noted at the ceilings.
- An active leak was noted at the Kitchen ceiling. I was unable to determine if the leak was from the water heater or one of the bathrooms. Recommend further evaluations and repairs as needed by qualified Plumbing Contractor.
- Signs of mold are present on ceiling in Kitchen . We did not inspect, test or determine if this mold is or is not a health hazard. Recommend you contact a mold inspector or expert for investigation or correction if needed. (Picture 1)

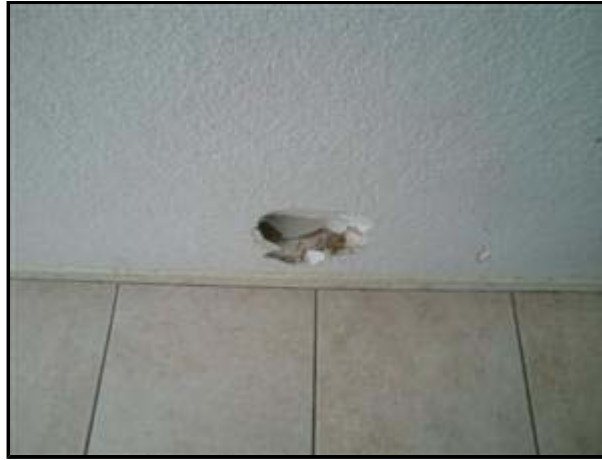
6.1 Picture 1

- Common cracks were noted at the interior walls.
- Damaged wall noted in Entry (Picture 1)

- Common cracks were noted at the interior walls.
- Damaged wall noted in Entry (Picture 1)

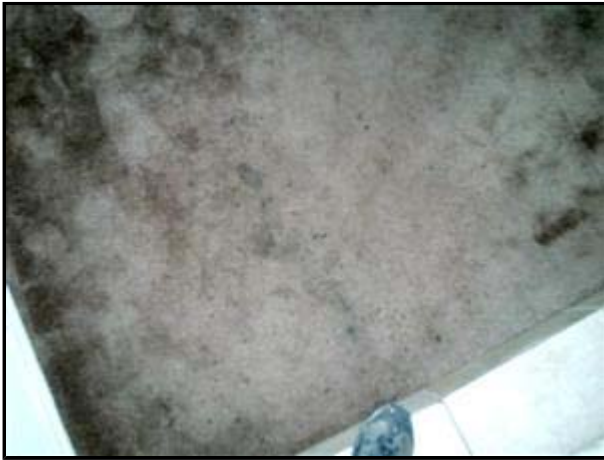
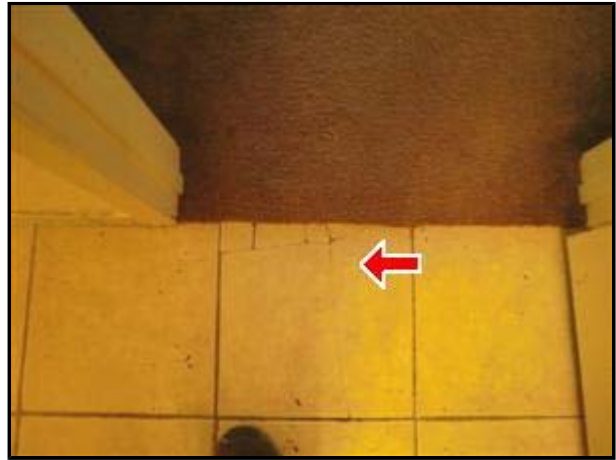
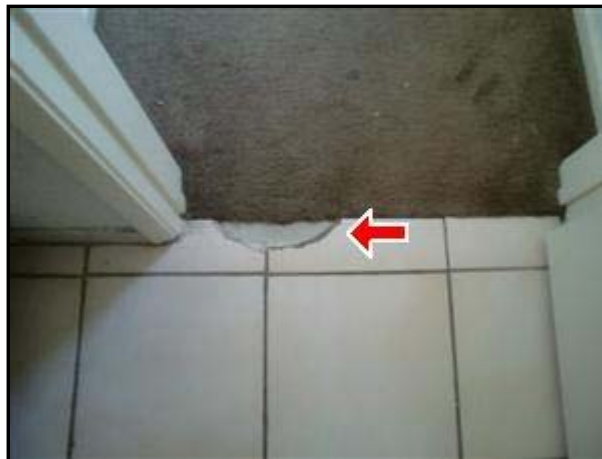
- Stained / worn floor covering noted at various areas. Appears to be at the end of useful life - replacement recommended. (Pictures 1-3)

- Stained / worn floor covering noted at various areas. Appears to be at the end of useful life - replacement recommended. (Pictures 1-3)

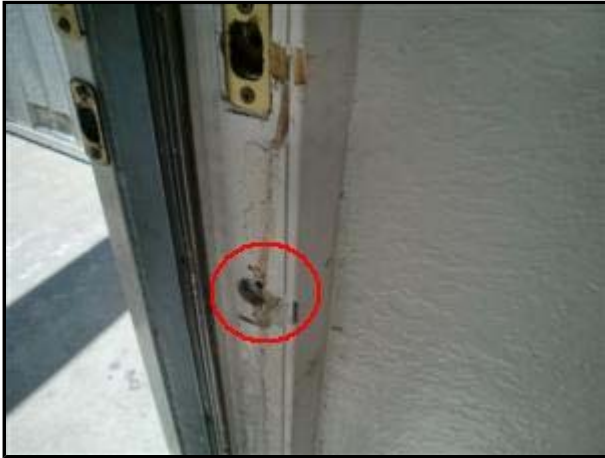
6.3 Picture 1

- Door stops are recommended at all interior doors in order to prevent damage to the interior walls.
- Missing catch plate noted at entry door - a security risk. Corrections recommended. (Picture 1)

- Door stops are recommended at all interior doors in order to prevent damage to the interior walls.
- Missing catch plate noted at entry door - a security risk. Corrections recommended. (Picture 1)
- Slider door is installed backward - it is possible to remove the door from the track from exterior - a security concern. (Picture 2)
- Missing cabinet door noted in Hallway (Picture 3)
- Missing closet doors noted in bedrooms. (Picture 4)
- Damaged door frame noted at Bedroom. (Picture 5)

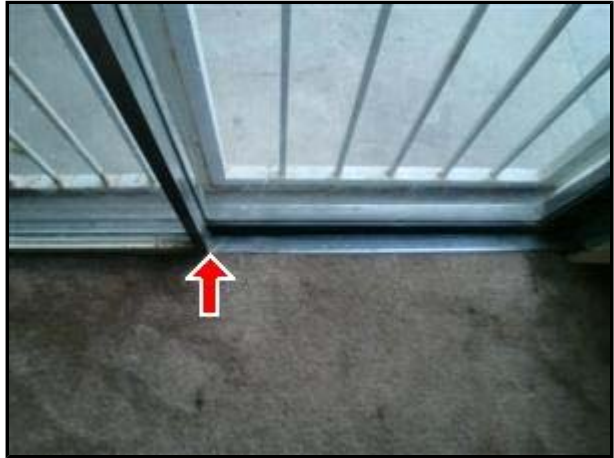
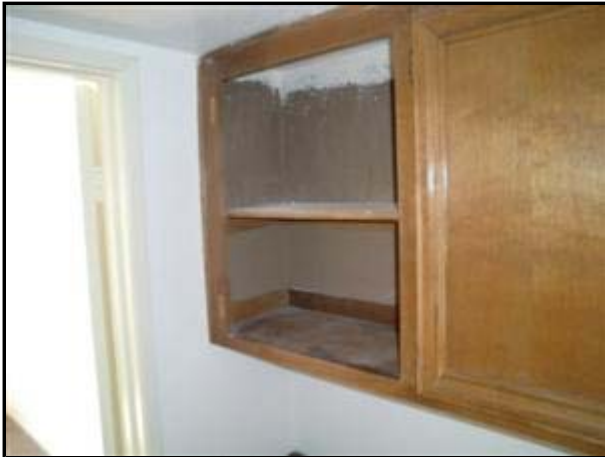
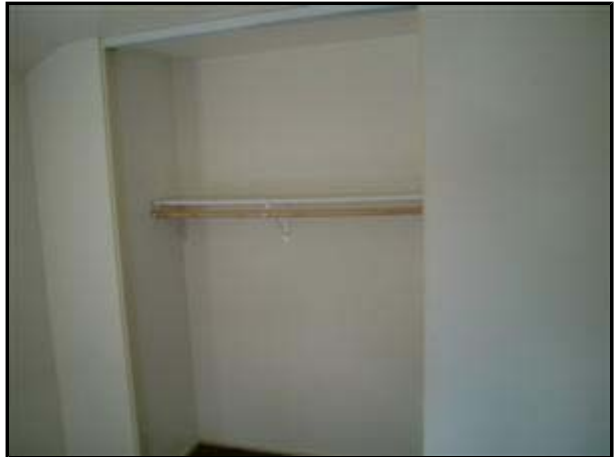
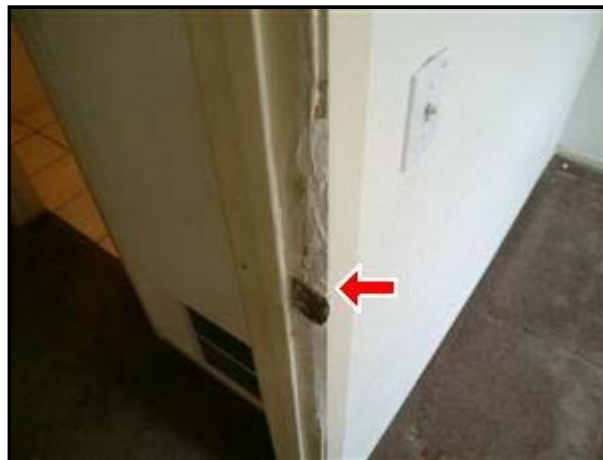
- Slider door is installed backward - it is possible to remove the door from the track from exterior - a security concern. (Picture 2)
- Missing cabinet door noted in Hallway (Picture 3)
- Missing closet doors noted in bedrooms. (Picture 4)
- Damaged door frame noted at Bedroom. (Picture 5)

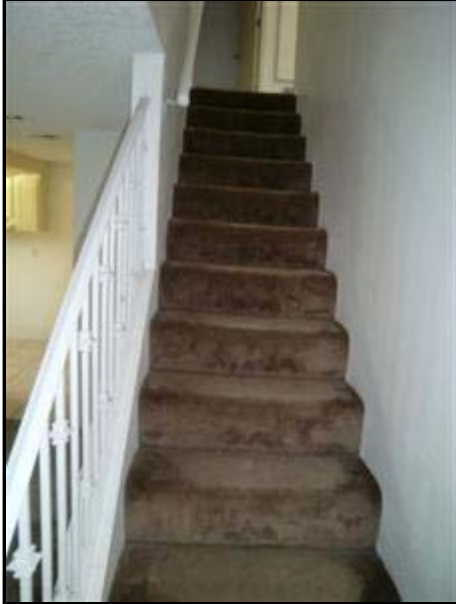
6.5 Picture 1

- Stairway (Picture 1)
- Handrail at interior stairs is not to current safety standards - does not return to wall at top landing - correction / safety upgrade recommended. (Picture 2)

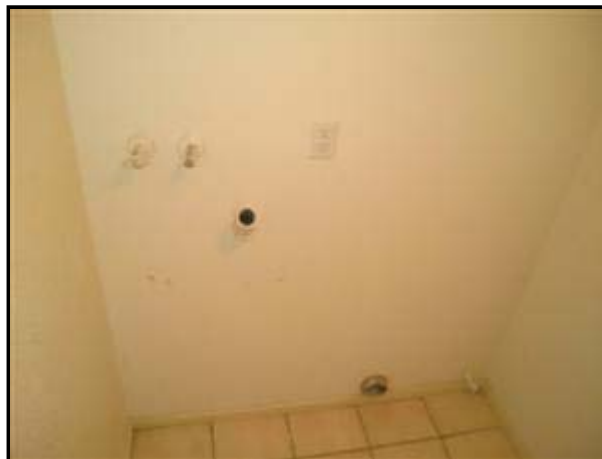
6.6 Picture 1

- GFCI outlet is recommended at laundry as a safety upgrade.
- Laundry machines, drains, supply valves/hoses not tested at this inspection. Check with the seller. (Picture 1)
- Recommend installing drip pan with exterior routed drain line.

- GFCI outlet is recommended at laundry as a safety upgrade.
- Laundry machines, drains, supply valves/hoses not tested at this inspection. Check with the seller. (Picture 1)
- Recommend installing drip pan with exterior routed drain line.

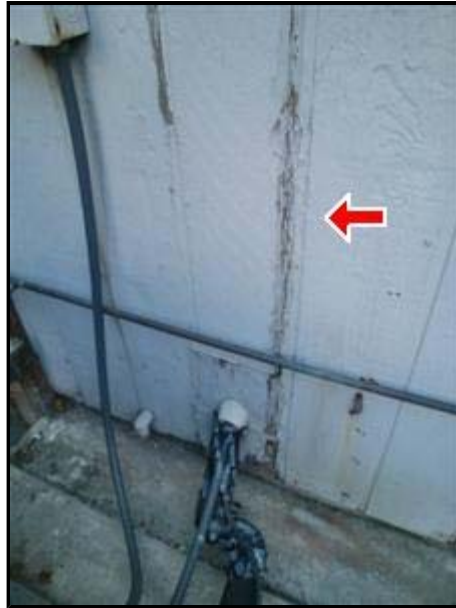
6.7 Picture 1

- Dry stains and some moisture damage noted at exterior wall - corrections recommended. (Picture 1)

- Dry stains and some moisture damage noted at exterior wall - corrections recommended. (Picture 1)

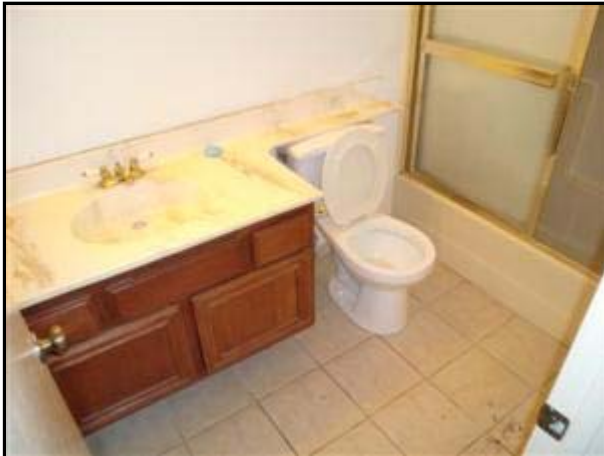
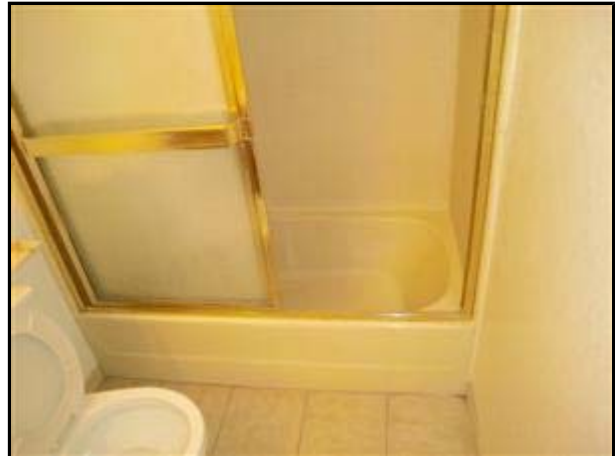
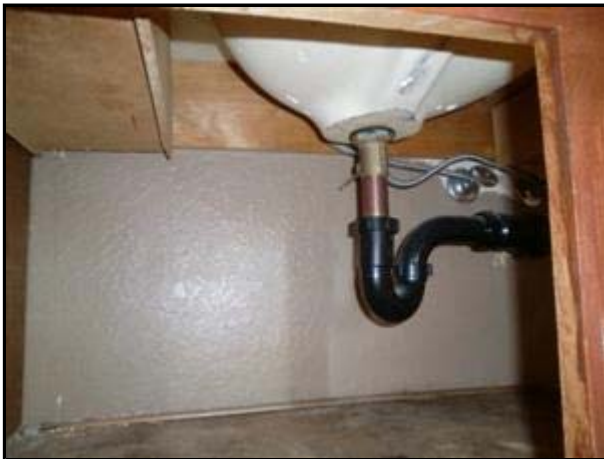
- Hallway Bathroom (Pictures 1-3)
- Toilet tank lid hits counter - can not fully install. Corrections recommended. (Picture 4)
- Caulk needed at sink counter. (Picture 5)
- Tub faucet continues to run when turned off. Recommend further evaluations and corrections as needed by qualified Plumbing contractor.

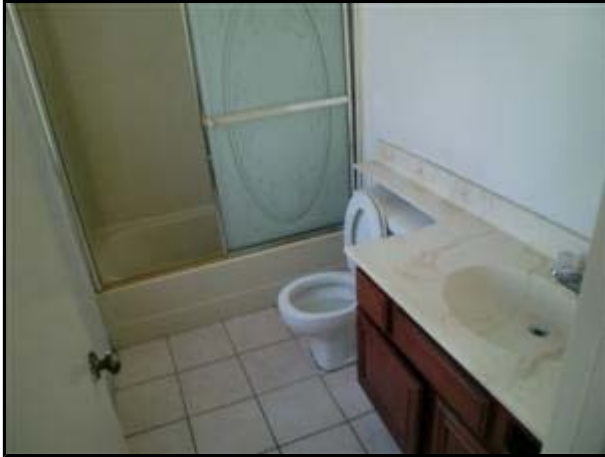
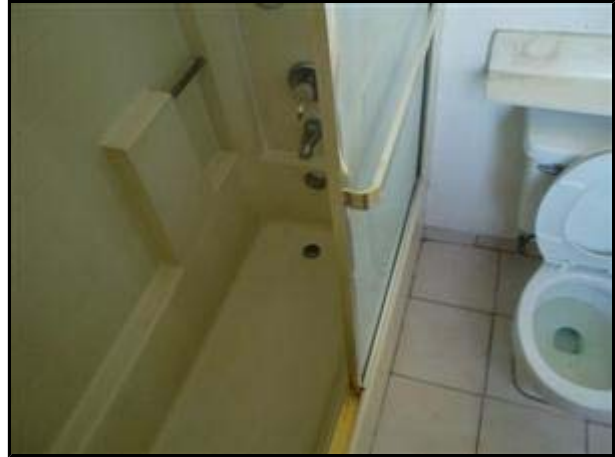
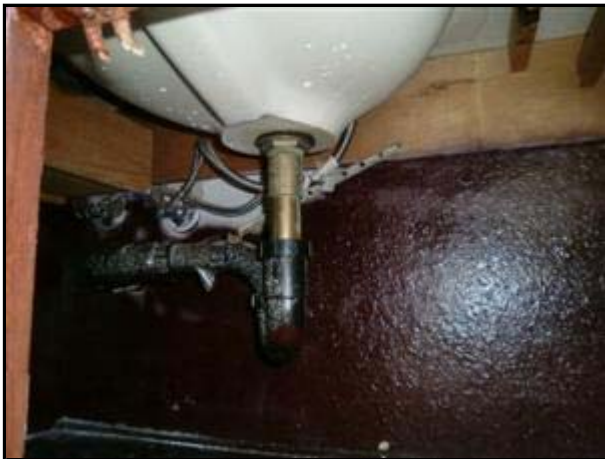
- Master Bathroom (Pictures 1-4)
- Missing drawer noted at cabinet. (Picture 4)
- Tub faucet pipes are loose at wall - improper. Recommend anchoring pipes to wall and caulking around tub faucet to help prevent moisture penetration / damage of wall. (Picture 5)

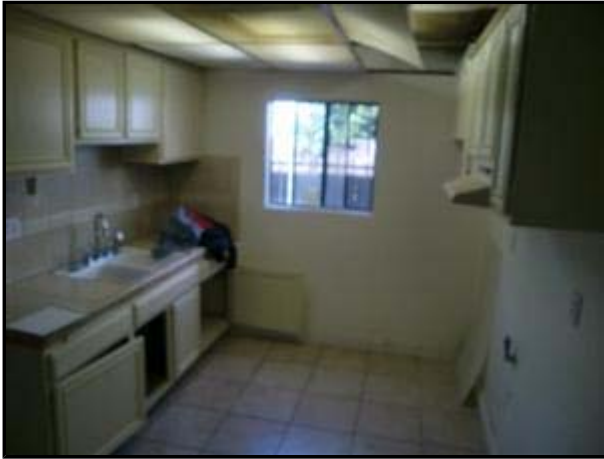
8.0 Picture 1

- Kitchen (picture 1)
- Moderate to heavy general wear and age defects were noted - upgrade / renovations recommended. (Pictures 2-3)
- Caulk needed at counter (Picture 4)

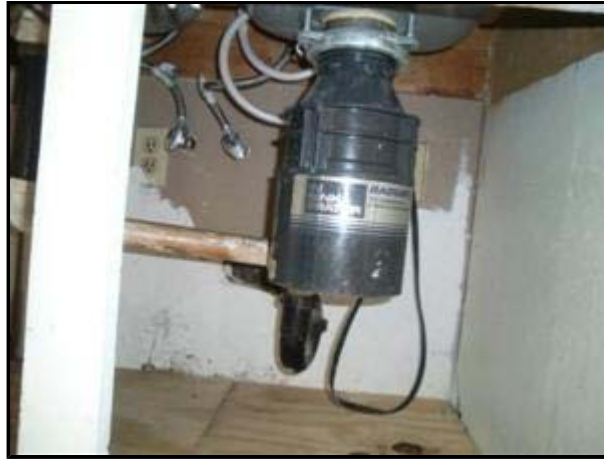
8.1 Picture 1

- Unit operated properly at time of inspection. (Picture 1)

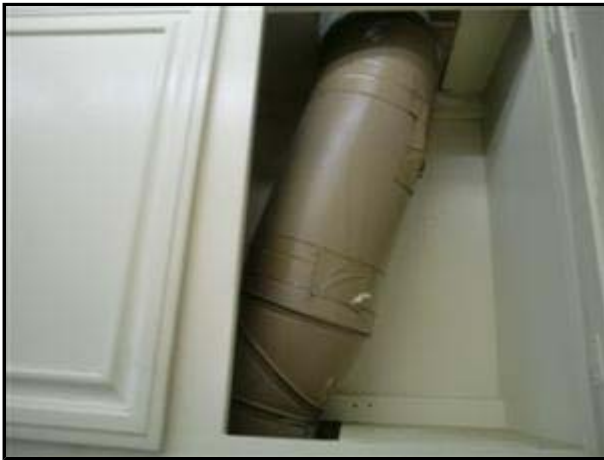
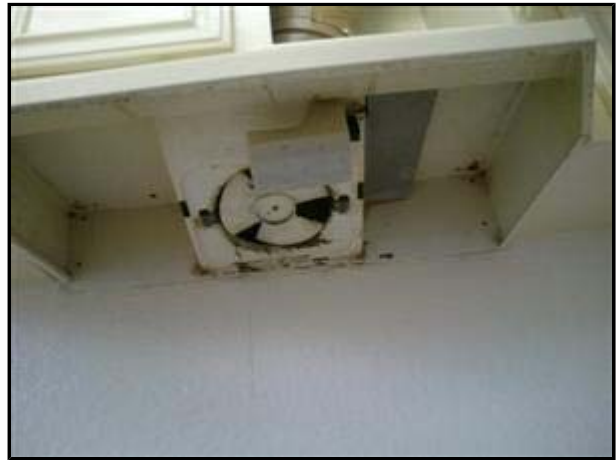
- Exhaust fan was not properly diverted at time of inspection (currently set up for ventilation, yet is recirculating instead). Recommend corrections for proper exhaust control. (Picture 1)
- Missing filter noted - replacement recommended. (Picture 2)
